McMichael Duplex Four – a chance discovery by Ray Bayliss

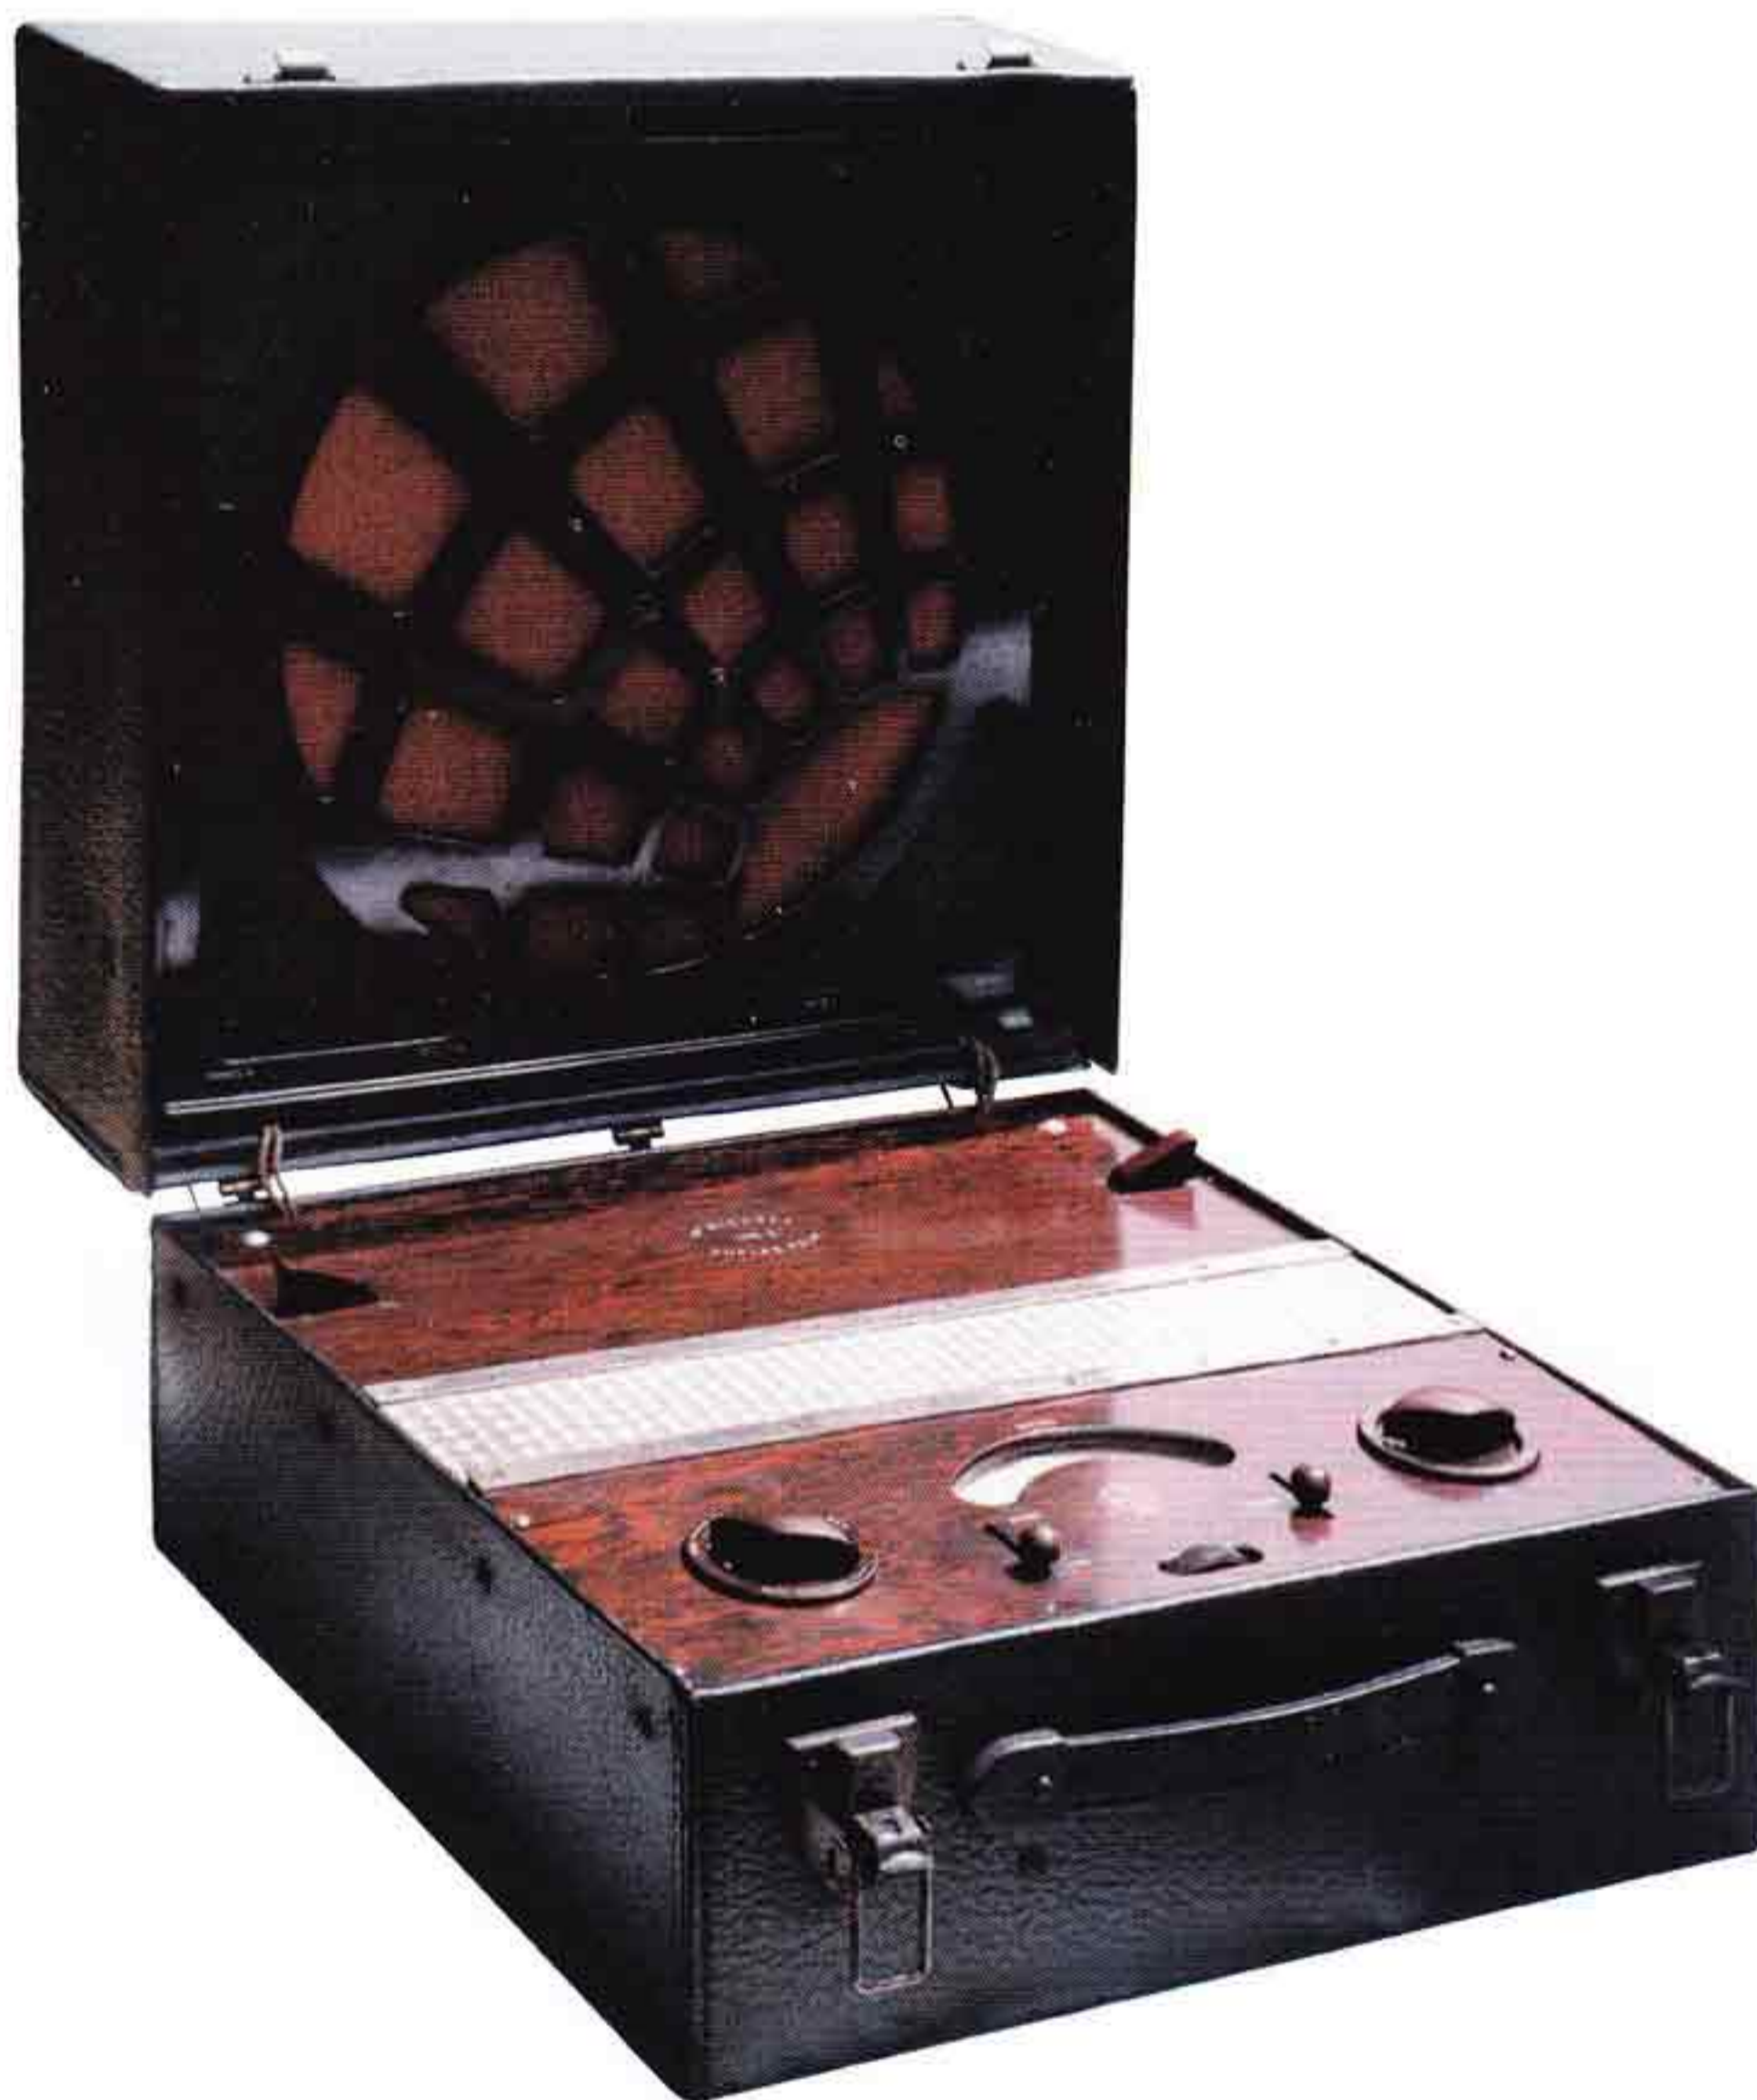
It was in 2006 that in connection with my other interest, namely vintage motorcycles, I attended a classic vehicle rally at Cranleigh, Surrey. In addition to the vehicles there were various stalls and on one of these was a tatty leather covered box which at first glance looked like an old portable gramophone. Opening the box I discovered that it contained not a gramophone but a McMichael Duplex Four Type S portable wireless and apart from a little dust and dirt it looked perfect!
